**Spectrally Enhanced Lighting Program  
Implementation for Energy Savings:**

***Field Evaluation***

Prepared by  
Pacific Northwest National Laboratory

August 2006

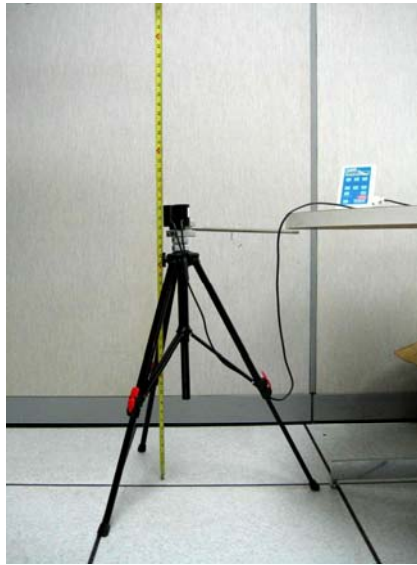
**Figure 2.2.** Illuminance Meter in Position to Take (A) Horizontal Measurements and (B) Vertical Measurements

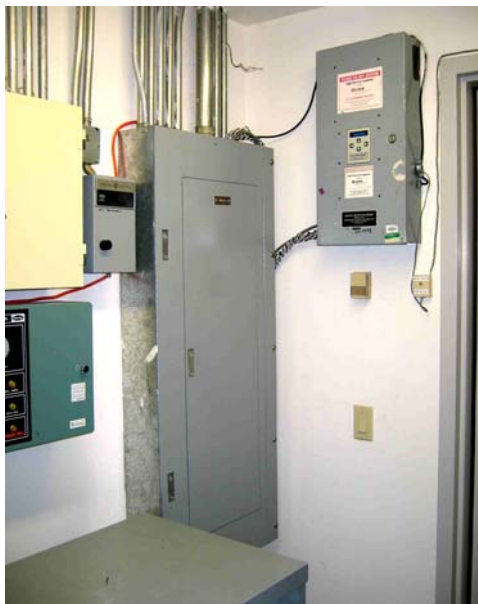
**Figure 3.1.** End Use Metering Logger. The box to the right of the control panel is one of two end use metering loggers used to measure current, power, and apparent power in Building A.

The fixtures affected by the retrofit are powered from eighteen 277-volt dedicated lighting circuits. Two end-use metering loggers were installed to monitor these circuits. One of the loggers is shown in Figure 3.1; the other logger installation is essentially identical. The pre-retrofit study period was August 10 to September 2, 2005, and the post-retrofit period was September 12 to October 15, 2005.

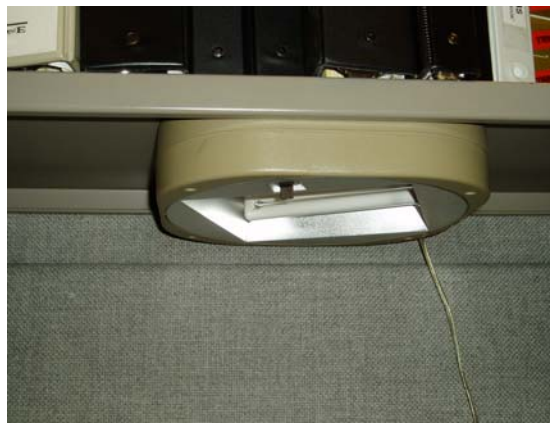
**Figure 3.11.** Building A Workstation Task Light

To assess pre- and post-retrofit task lighting use, individual data loggers were deployed at a sample of the building's workstations. Figure 3.10 and 3.11 show one style of task light and workstation/cubicle present in Building A. The lighting data loggers used were Onset Computer Hobo® H-8 models (see Appendix D for specifications). These were installed on or near 45 workstation task lights. The loggers were set to sense whether the task light was on or off by measuring the light intensity coming from the fixture at 10-minute intervals. Data were collected for more than two weeks in both the pre- and post-retrofit periods. The post-retrofit data were collected after the three-week adaptation period to allow for occupant adjustment to the new overhead lighting.

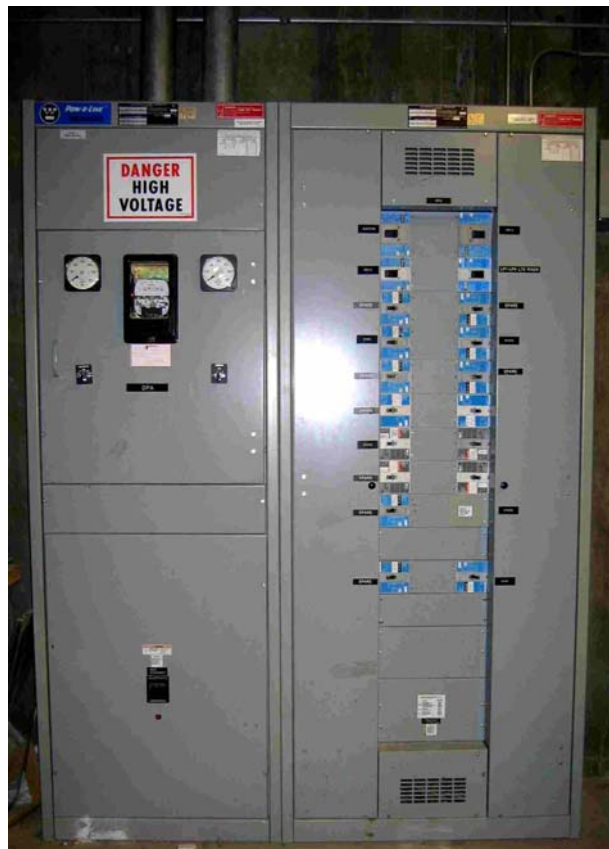
**Figure 4.2.** Building B - Distribution Panel with Three-Phase Lighting Riser Logger Installed in Right-Hand Compartment

The fixtures affected by the retrofit are powered from three 277-volt dedicated interior lighting panels on the second through fourth floors (one panel per floor) and a mixed lighting panel on the first floor. The first floor panel serves exterior and stairwell lighting as well as the overhead office lighting. Two loggers were installed to monitor lighting power. An end-use metering logger was installed at the first-floor lighting panel similar to the installation shown in Figure 3.1 for Building A. A four-wire three-phase power logger was installed on the lighting riser circuit of the distribution panel in the main electrical room as shown in Figure 4.2. The total overhead lighting load is taken to be the riser load minus the exterior and stairwell loads. The pre-retrofit study period was October 13 - November 4, and the post-retrofit period was November 7 – December 6, 2005.

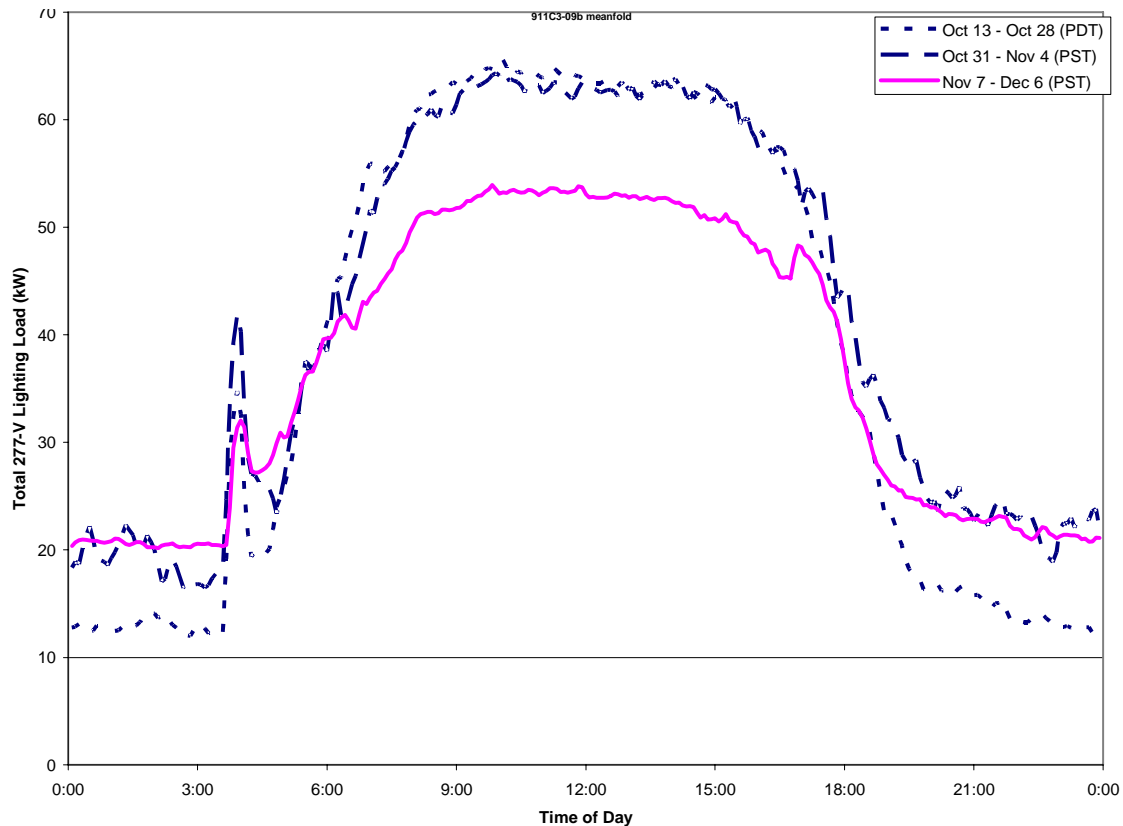
**Figure 4.6.** Building B Mean Pre- and Post-Retrofit Workday Load Profiles

The mean daily profiles, after removing exterior lighting loads, are shown together in Figure 4.6. The two pre-retrofit profiles (Figures 4.3 and 4.4) show that a significant change in nighttime lighting use occurred with the change from daylight-savings to standard time on October 30. We postulate that the seasonal onset of afternoon darkness results in more lights being left on.

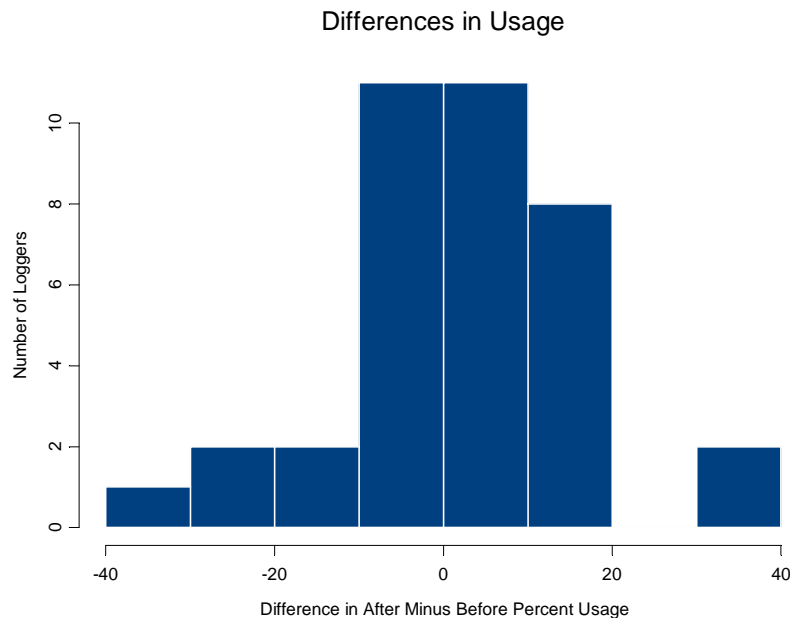
**Figure 4.14.** Building B - Task Lighting Logger Differences in Usage Before and After Retrofit

Figure 4.14 is a difference usage chart representing the percentage usage for each logger before and after retrofit. The plotted differences show the data has an approximate normal distribution – with a small tail to the left.

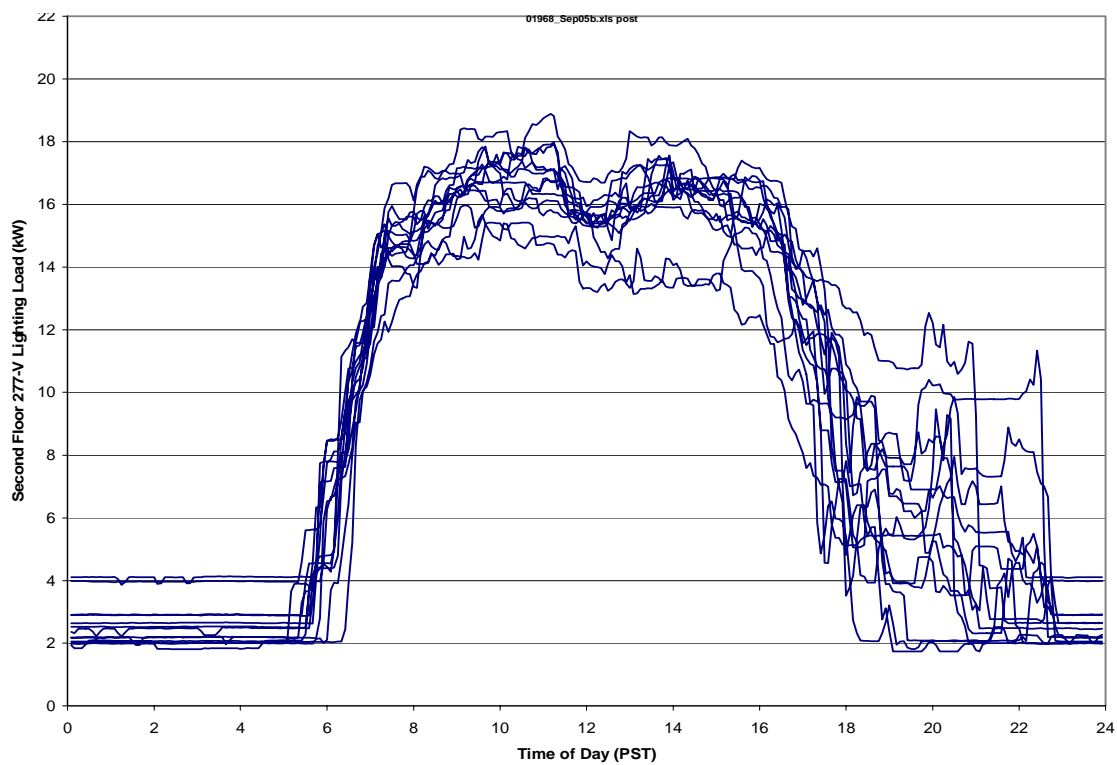
**Figure 5.6.** Building C Second-Floor Post-Retrofit Weekday Load Profiles, Oct. 31 –Nov. 22, 2005

Daily lighting load profiles are shown for pre-retrofit weekdays (Sept. 26-Oct. 17) in Figure 5.5 and for post-retrofit weekdays (Oct. 31 - Nov. 22) in Figure 5.6. Each daily load profile is a separate line in Figures 5.5 and 5.6.
